# Ordnance Products, Inc. Superfund Site

Prioritization Panel  
Funding Request  
November 2013  
Groundwater Remedy

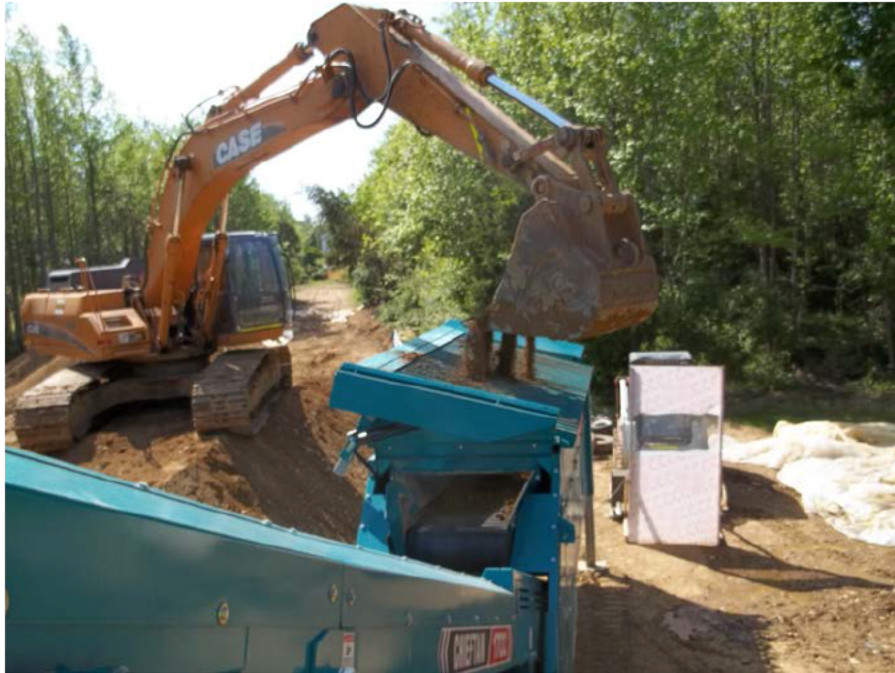
MEC Screening

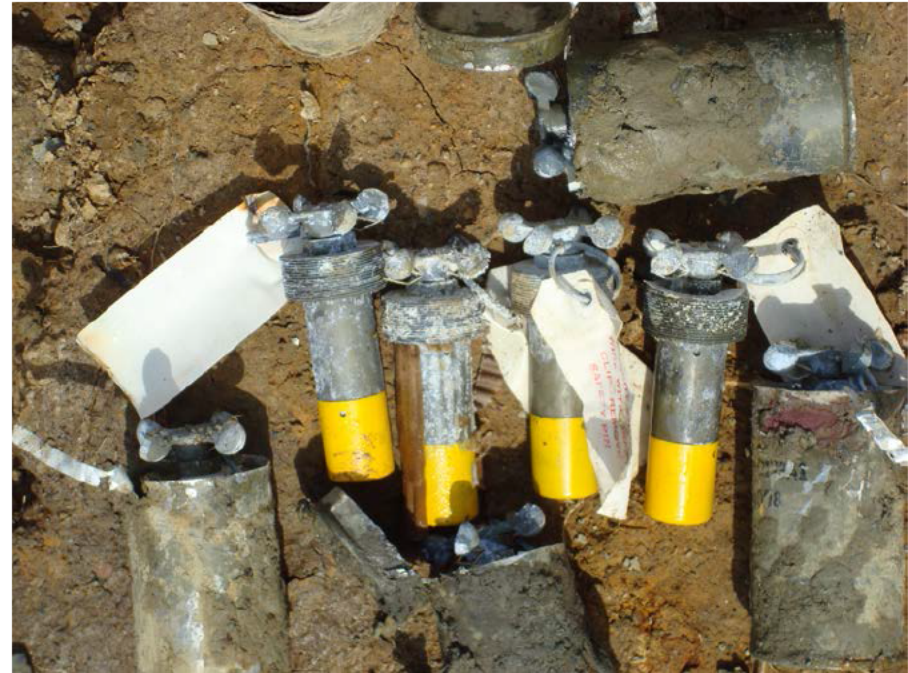
Excavated MEC  
(Napalm Detonators)

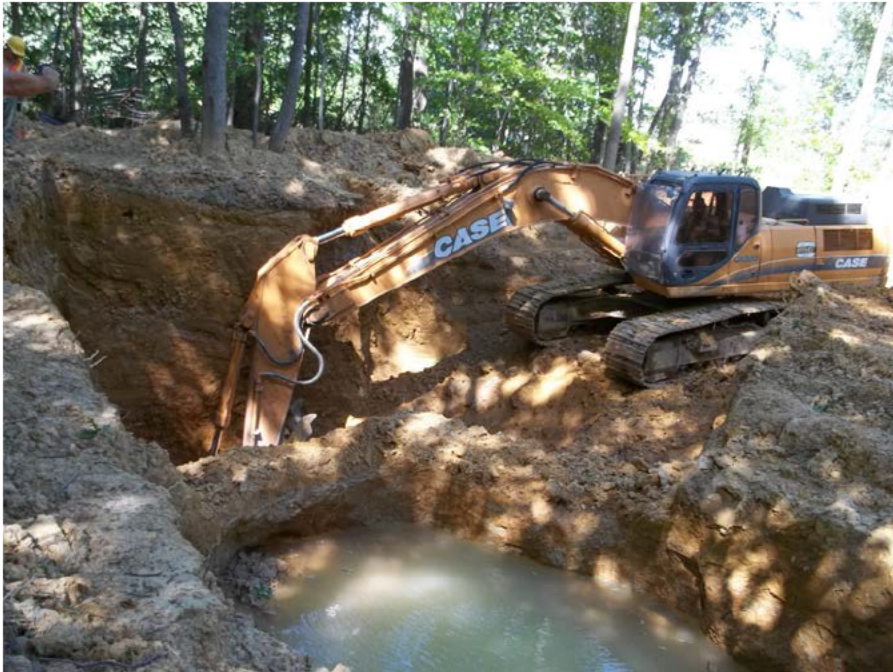
Contaminated Soil Excavation  
(Area D)

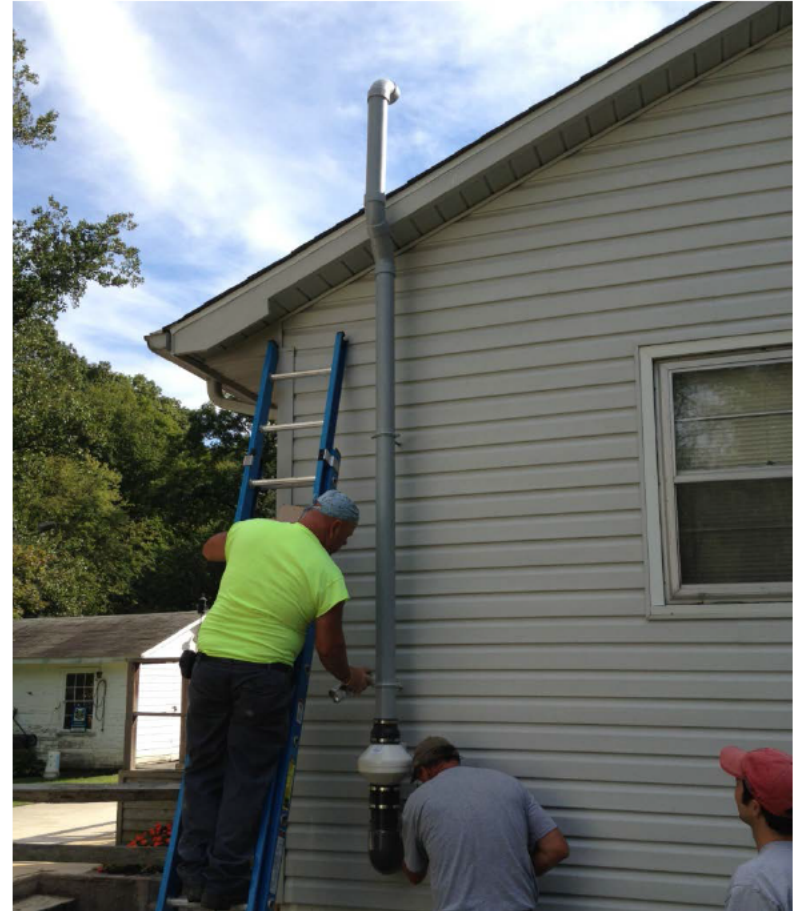
VI Mitigation System Installation

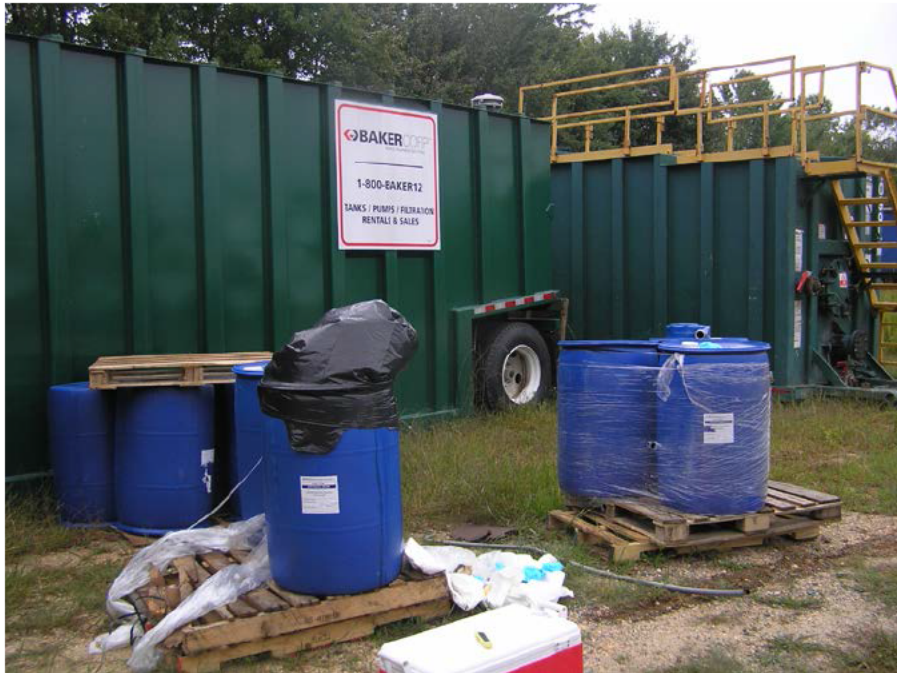
Bioremediation Treatability Study  
Equipment

- Two separate groundwater contaminant plumes;
  - » Plume 1 – Northern portion of Site, extends offsite, VOCs only;
  - » Plume 2 – Southern portion of Site, contained onsite, VOCs and perchlorate.
- Pre-Design Investigation;
  - » Additional monitoring and extraction/injection wells installed at both plumes;
  - » Long-term pumping tests completed at both plumes;
  - » Existing groundwater treatment system building evaluated for reuse;
  - » Treatability study conducted to evaluate in-situ bioremediation in Plume 2.

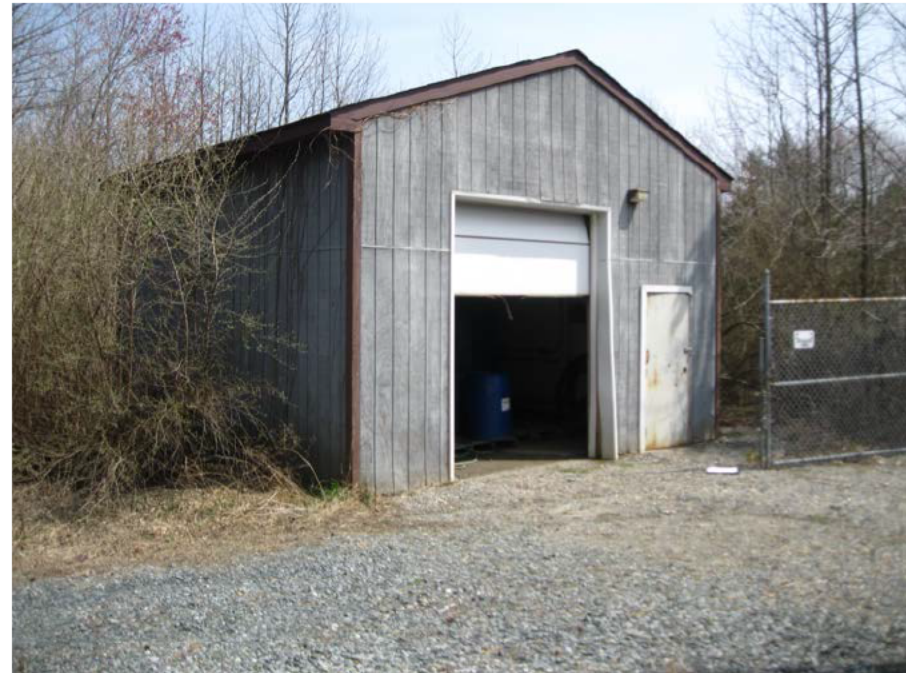
Existing Groundwater Treatment  
System Building
